Technical Memorandum No. MERL-08-6

Results of Laboratory Physical Properties and Hole Erosion Tests, Truckee Canal Embankment Breach, Newlands Project, Nevada

March 2008

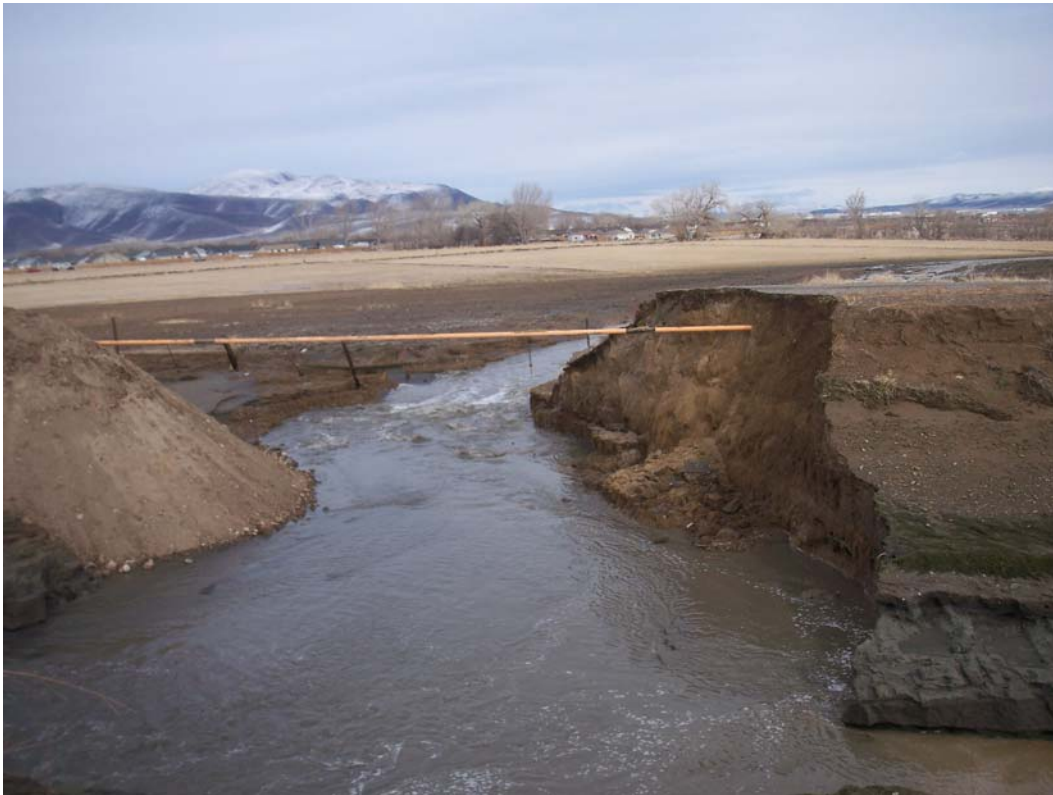
Figure 1. — Truckee Canal breach at station 714+00, 8.5 hours after breach [4]. Canal flow is normally left to right. Material is already being pushed into the left side of the breach to form a temporary breach plug. Photo by Kenneth Parr, 1:04pm, 1-5-08.

Figure 1 shows the breach opening, about 8.5 hours after the failure occurred. The breach apparently developed and enlarged over a 2 to 3 hour period. The first report of a problem came shortly before 4:30 a.m., and the first eyewitness at the breach site reported the breach to be about 15 ft wide between 4:40-5:00 a.m., with the canal water surface only about 8 inches below the normal operating level. At 5:45 a.m. a second eyewitness estimated the breach to be 20 ft wide with flow 1 ft deep through the opening. The first eyewitness returned to the site at about 6:30-7:00 a.m. (after canal check gates had been shut to limit flow toward the breach site) and reported the breach to be larger than on his first visit, and the canal level dropped. From the photographs shown here and other information, the final breach opening is estimated to be about 18 ft deep and 25 to 35 ft wide. Immediate efforts to plug the breach prevented detailed measurements of the breach geometry.

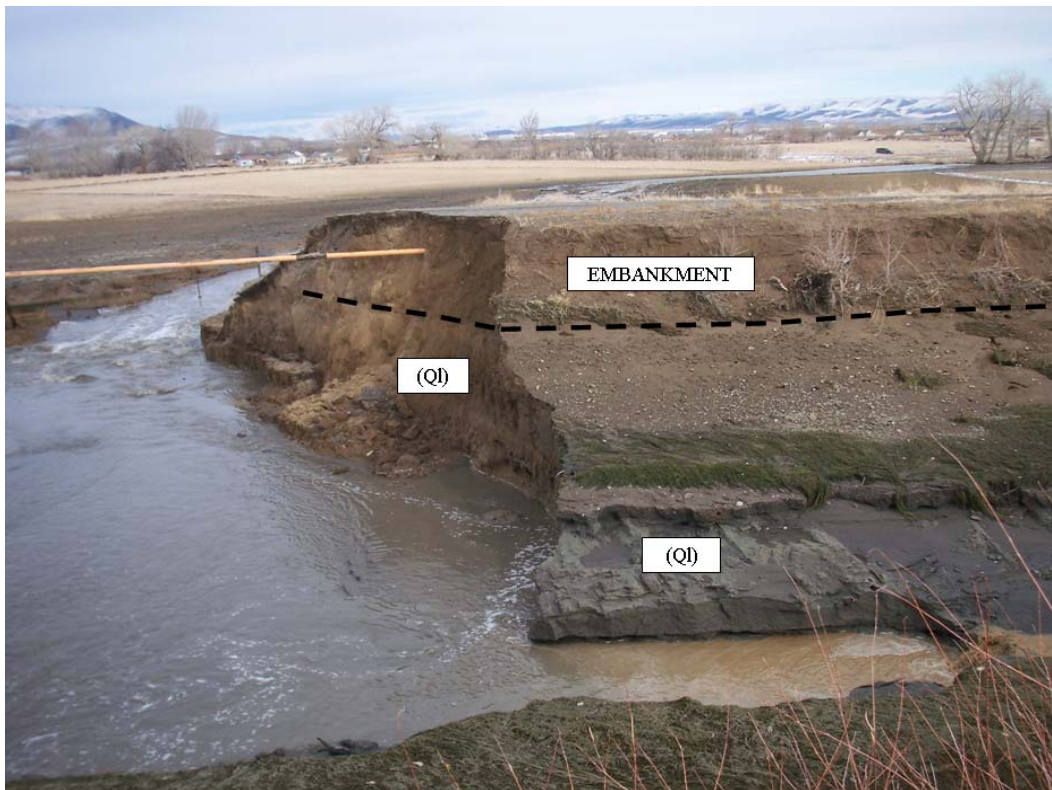
Figure 2. — Embankment and foundation layers at the breach site [4]. Photo by Kenneth Parr, 1:04pm, 1-5-08.

Figures 2 and 3 show the canal embankment and foundation geology in greater detail. The canal embankment is a cut-and-fill structure, with the canal excavated into Quaternary Lahontan Lakebed deposits (Ql) composed of high fines content Silt (ML) and Silt with Sand (ML)s, with minor beds of Elastic Silt (MH) and Fat Clay (CH). The canal banks are built up from the excavated materials, founded on undisturbed lakebed deposits. The fill material at the site of the breach is about 8 ft thick.

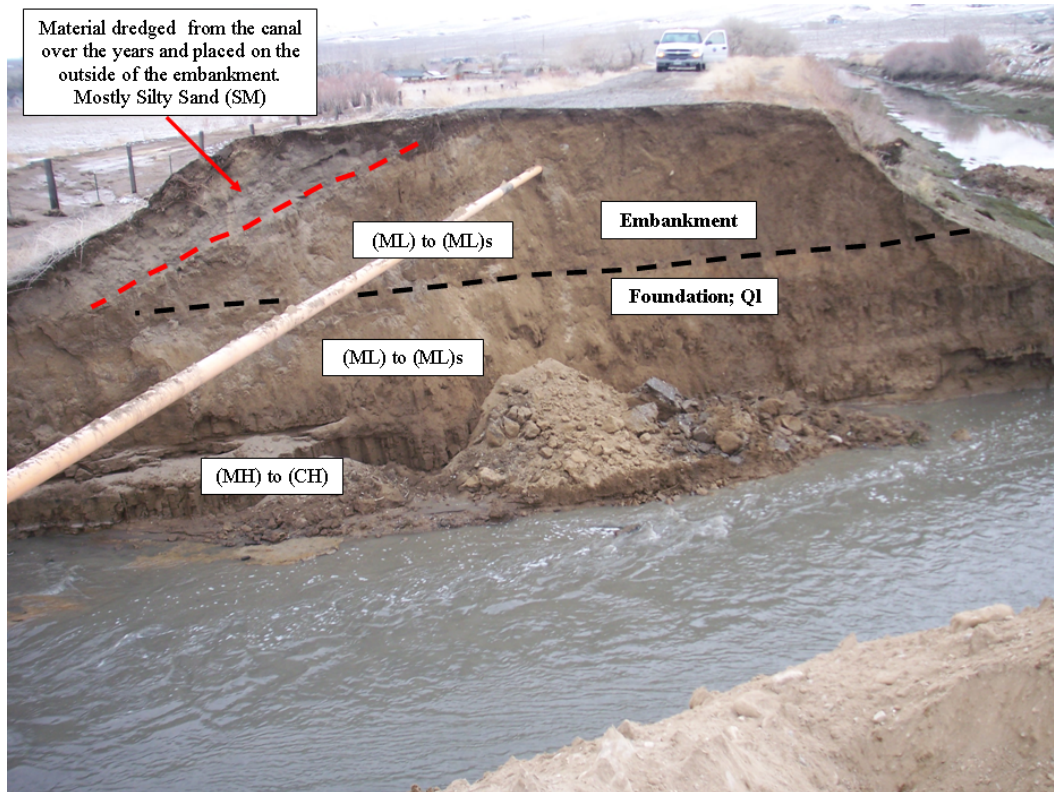
Figure 3. — Downstream view of the Truckee Canal Breach [4]. Dashed black line is the approximate contact between the canal embankment and in-place lakebed deposits (Q1). Center-left is an abandoned Sierra Pacific Power gas pipeline. Photo by Kenneth Parr, 2:07pm, 1-5-08.

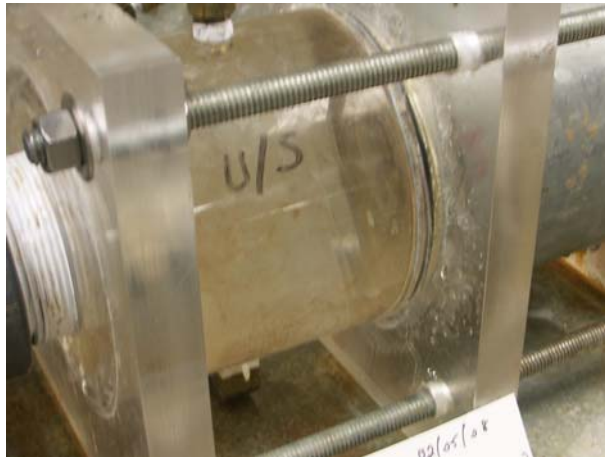
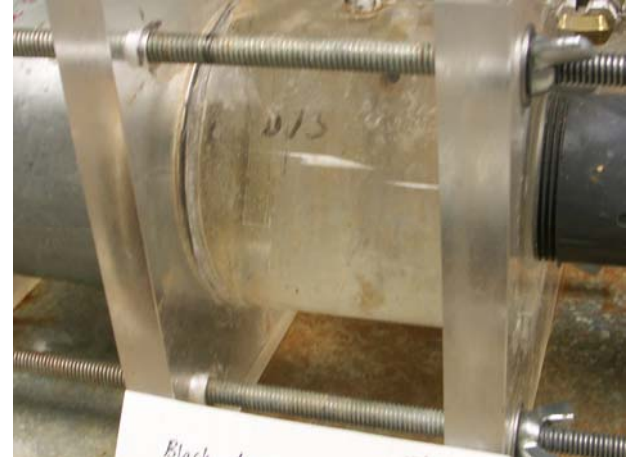
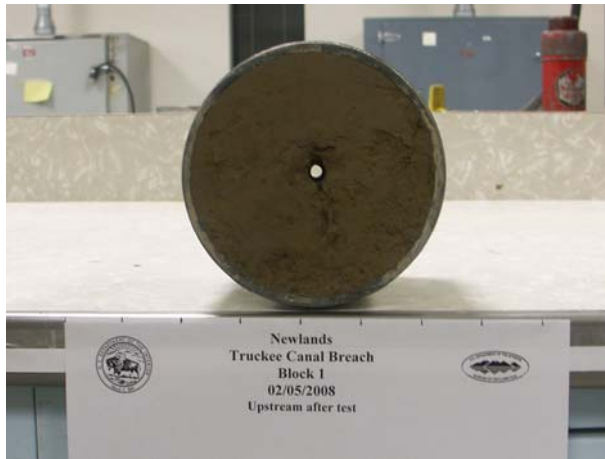
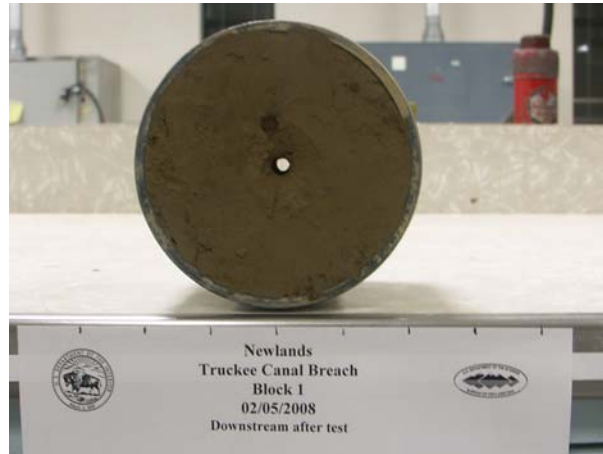
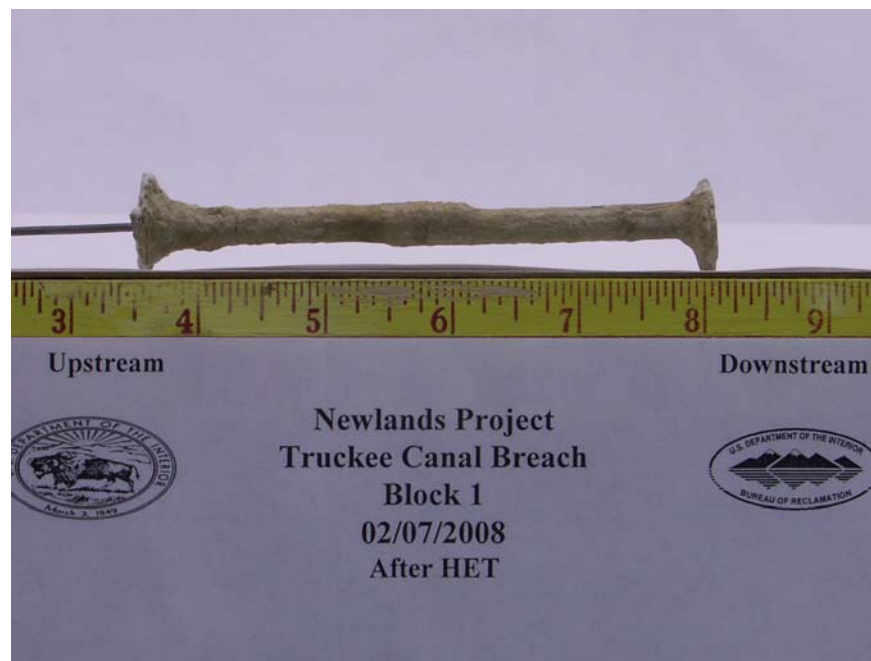
Figure 4 – Block 1 HET1 specimen photos (a) U/S, and (b) D/S, 8 minutes from start of HET at head 50 mm, (c) U/S, and (d) D/S, 55 minutes from start of HET at maximum head 1580 mm

Figure 4 (continued) – Block 1 HET1 specimen photos (e) U/S, (f) D/S ends showing final hole diameter, and (g) final hole cast in hydrostone. This test produced no significant erosion.

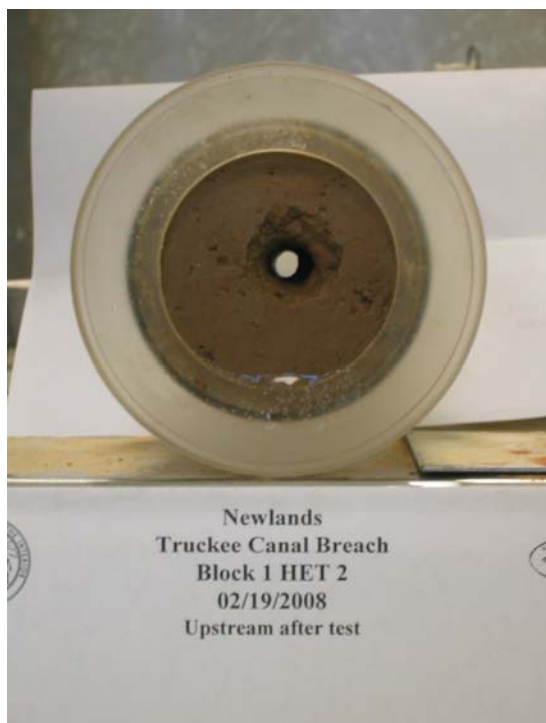
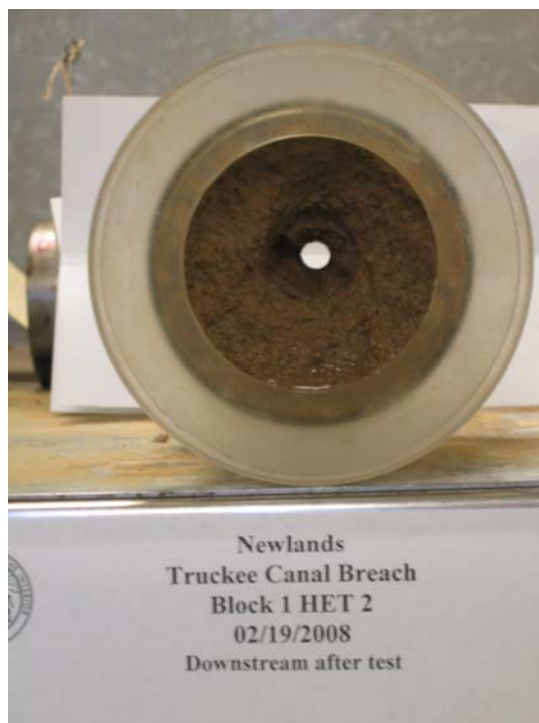
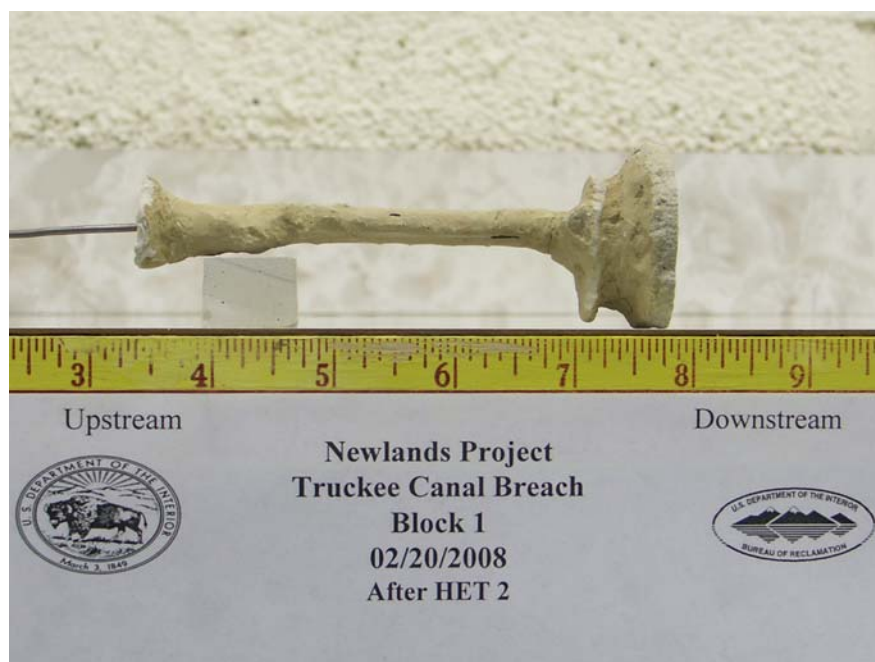
Figure 5 – Block 1 HET2 specimen photos (a) U/S, (b) D/S ends showing final hole diameter, and (c) final hole cast in hydrostone. This test produced only slight erosion, not significant enough to allow determination of erodibility parameters.

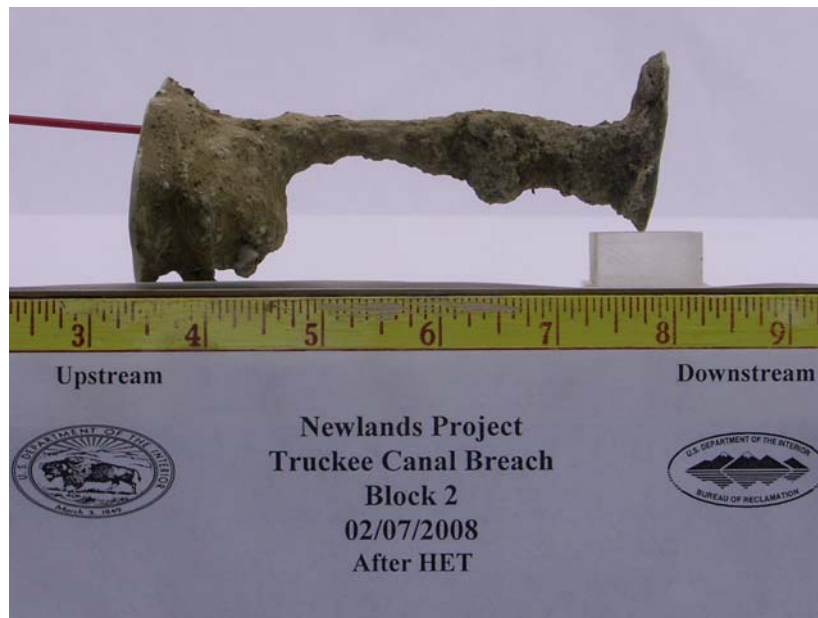
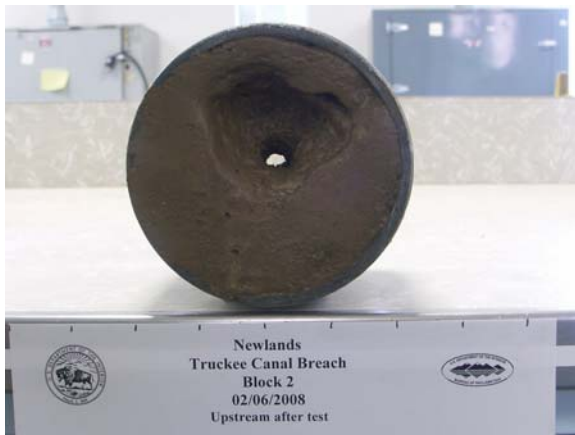
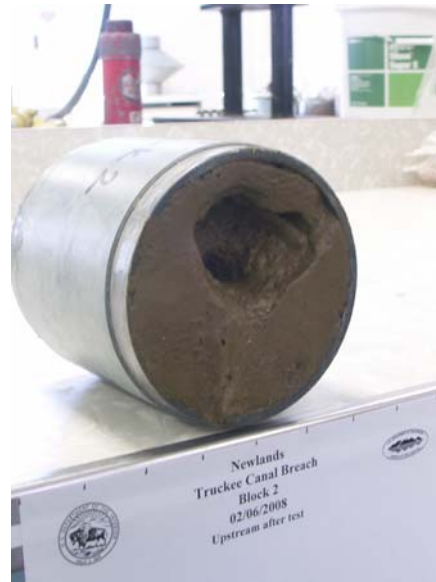
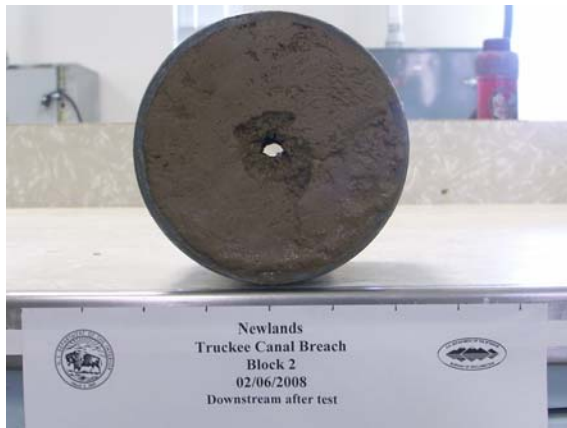
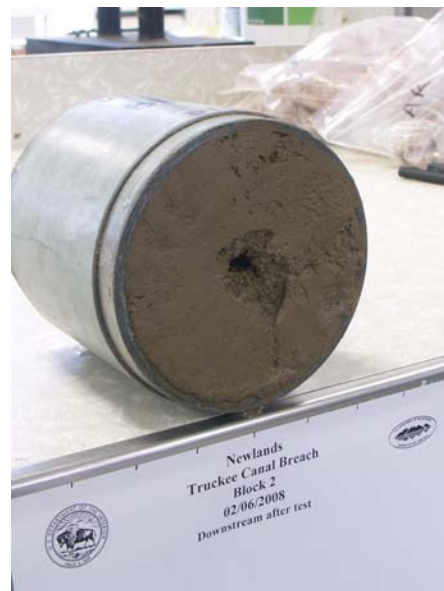
Figure 6 – Block 2 HET1 specimen photos (a) at 20 minutes from start of HET showing U/S and D/S. (b) Final hole cast in hydrostone. This test produced insufficient erosion to allow determination of erodibility parameters. Note the minimum section which is essentially unchanged from the pre-drilled hole diameter.

Figure 6 (continued) – Block 2 HET1 specimen photos (c) and (d) U/S, and (e) and (f) D/S ends after HET. Enlargement of hole was not sufficient to allow determination of erodibility parameters.

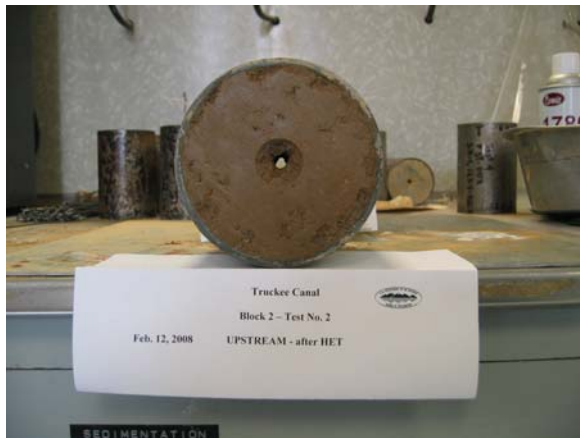
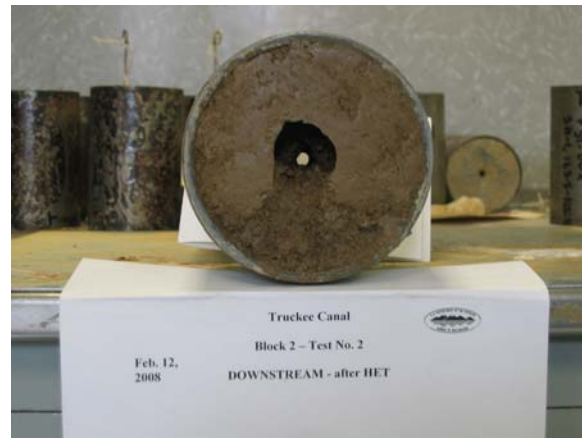
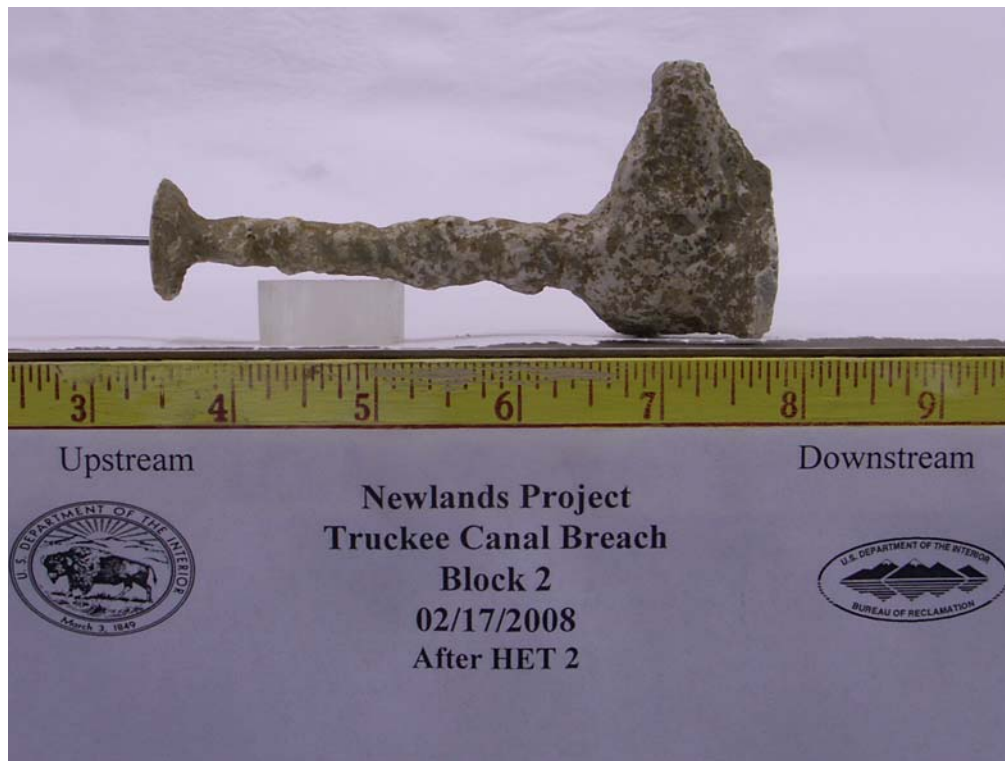
Figure 7 – Block 2 HET2 specimen photos (a) U/S, (b) D/S ends showing final hole diameter, and (c) final hole cast in hydrostone. This test was successful. Note that except for the downstream scour hole, there was relatively uniform enlargement of the full length of the pre-drilled hole.

HET3	100	25.5	70.3	8.5	3.6 to 3.8	7 to 14	3 - Moderately rapid	Reversed test specimen to place top of block downstream (due to perceived slightly disturbed condition of upstream side of sample). Good test with accelerating flow rate throughout test, indicating progressive erosion and enlargement of the hole. There was some scour of the downstream end of the hole (last 30 mm), but analysis could be performed because there was also enlargement of the full length of the hole during the test.
TP-07-1 at 0-7 ft	HET5	50	19.9	80.6	collapsed, hole not visible	---	---	---	This test was run without end plates or upstream turbulence filter. Unable to analyze result. Bonelli analysis which does not require final diameter is also inconclusive because sample collapsed before enough data could be collected to allow a meaningful curve-fit analysis.
	HET6	60, 100, 200, 400	19.9	80.9	25 mm (hole remaining after breach of specimen due to upstream and downstream scour.	---	---	---	This test used 25 mm end plates and an upstream turbulence filter. Erosion occurred immediately at 50 mm head, but consisted mostly of scour at downstream and upstream ends. Head was increased several times in effort to produce enlargement of hole, but this was unsuccessful. The downstream headcutting and upstream scour eventually reached one another and the sample breached catastrophically, even though flow had not increased significantly up to this point (except due to increasing the head). Unable to interpret test quantitatively.

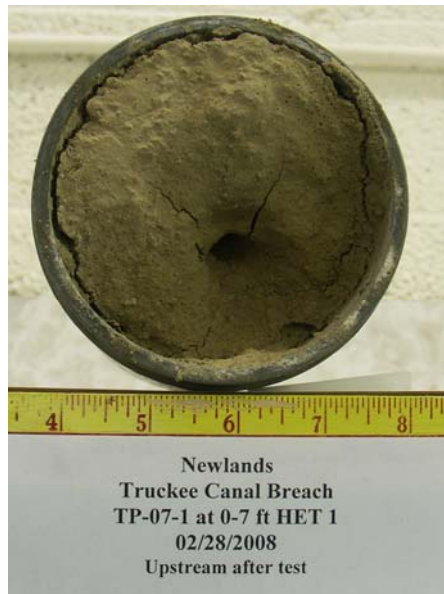
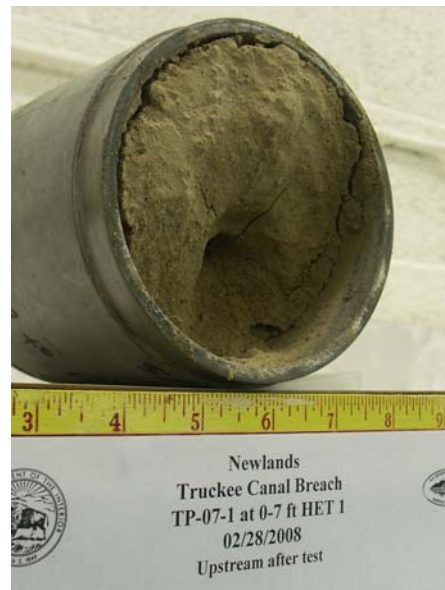
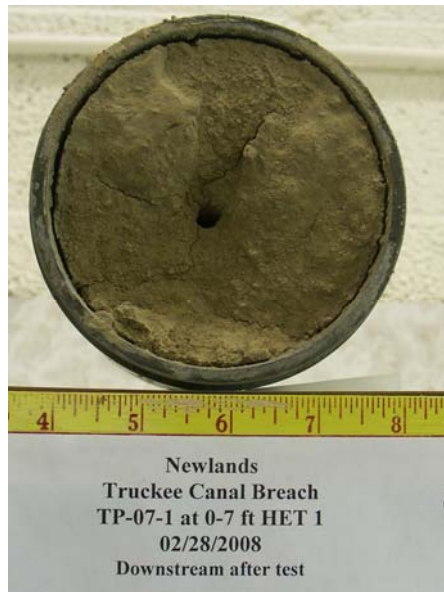
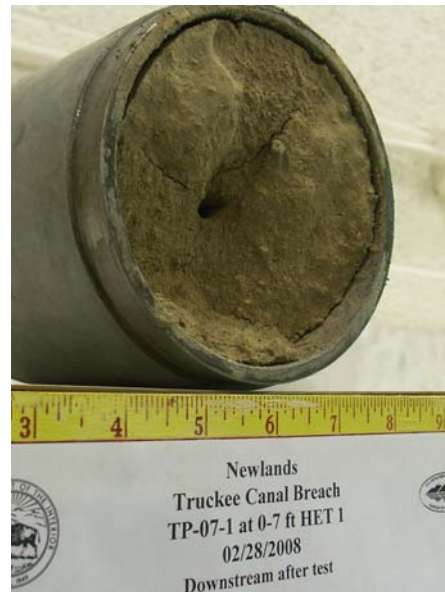
Figure 8 – TP-07-1 HET1 (a) and (b) U/S, and (c) and (d) D/S after HET. Unable to measure final hole diameter due to material collapse.

Four HETs and two JETs of the sample TP-07-1 were performed. All HETs were unsuccessful. Samples were compacted 2% dry of optimum moisture content to approximately 80% of maximum dry unit weight. In this condition, these samples were so weak that scour occurred and soil collapsed around the entrance and exit of the pre-drilled holes, even with end plates and the geotextile mesh installed. This erosion behavior dominated all of the tests. Because none of these tests produced the intended erosion mechanism, a quantitative analysis could not be performed. Attempts were made to increase the test head in hopes of obtaining immediately hole enlargement before scour of the entrance and exit could occur, but this was also unsuccessful.

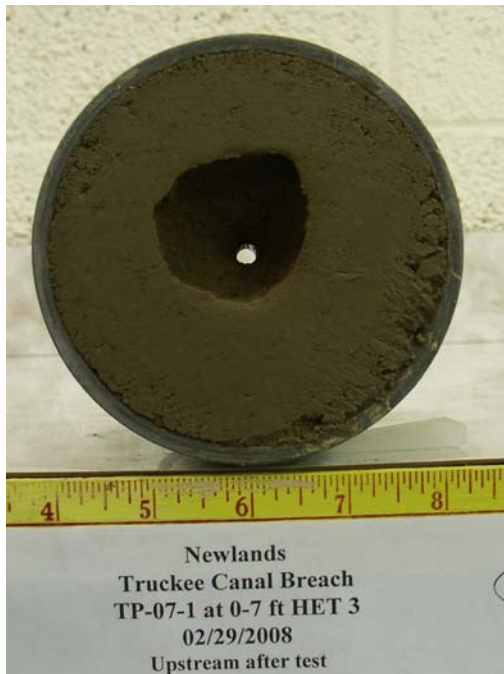
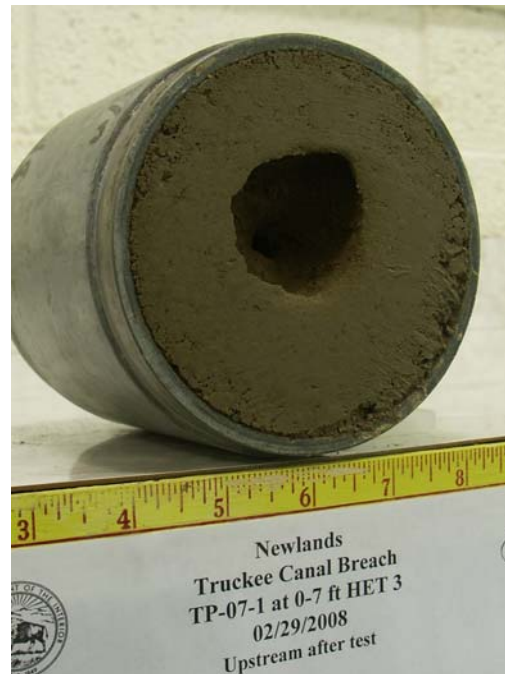
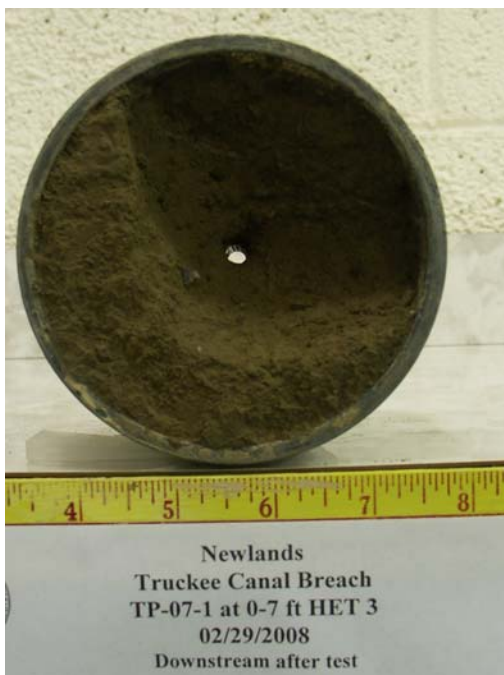
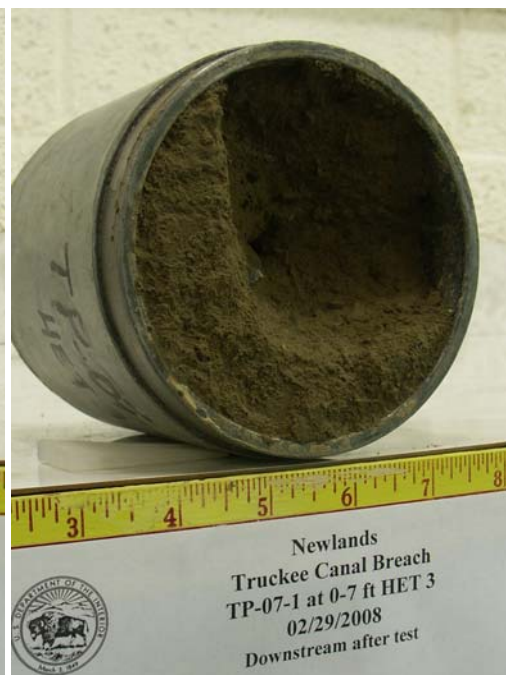
Figure 10 – TP-07-1 HET3 specimen photos (a) and (b) U/S, and (c) and (d) D/S after test. This test was unsuccessful. Scour erosion at the entrance and exit dominated the test. Note the lack of any enlargement of the small remnant of the pre-drilled hole.

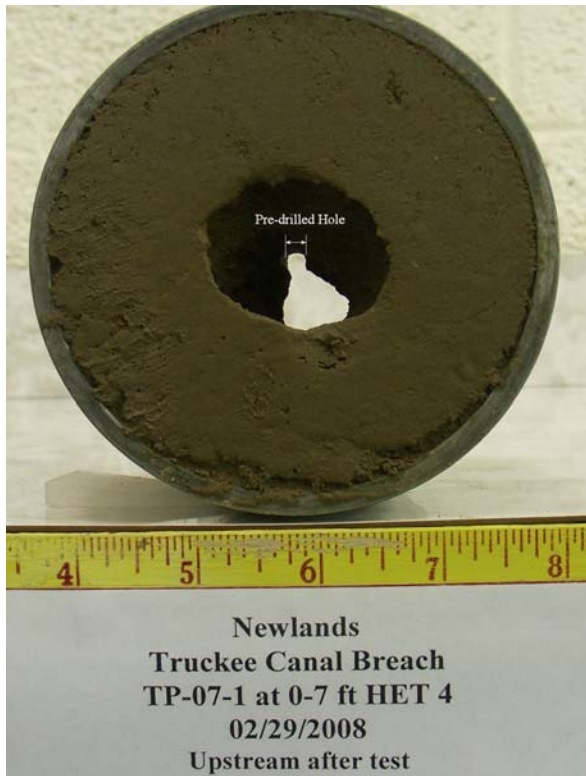
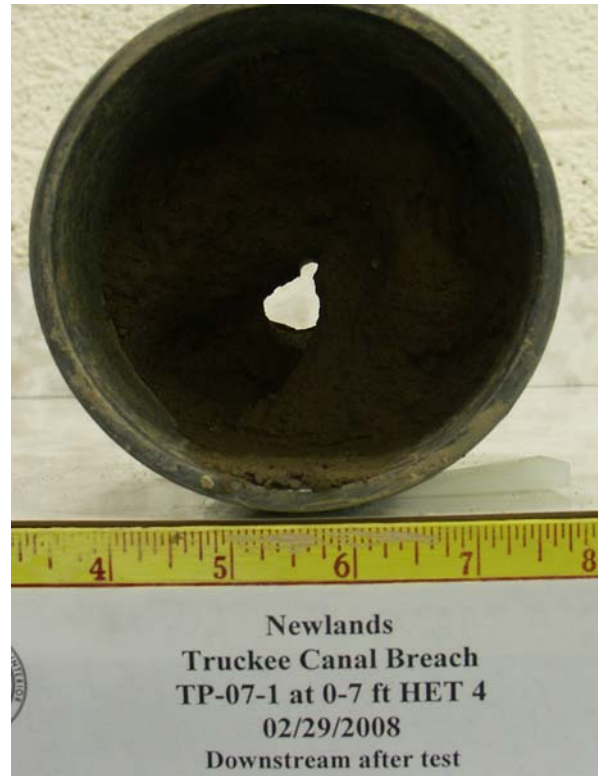
Figure 11 – TP-07-1 HET4 test specimen photos (a) U/S and (b) D/S after test. This test was unsuccessful. Note the lack of any enlargement of the small remnant of the pre-drilled hole.

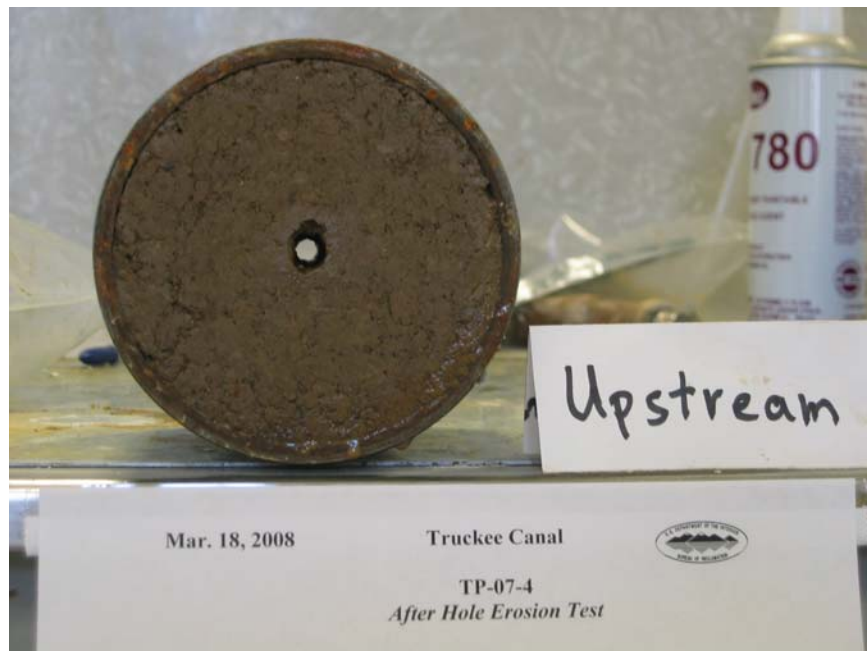
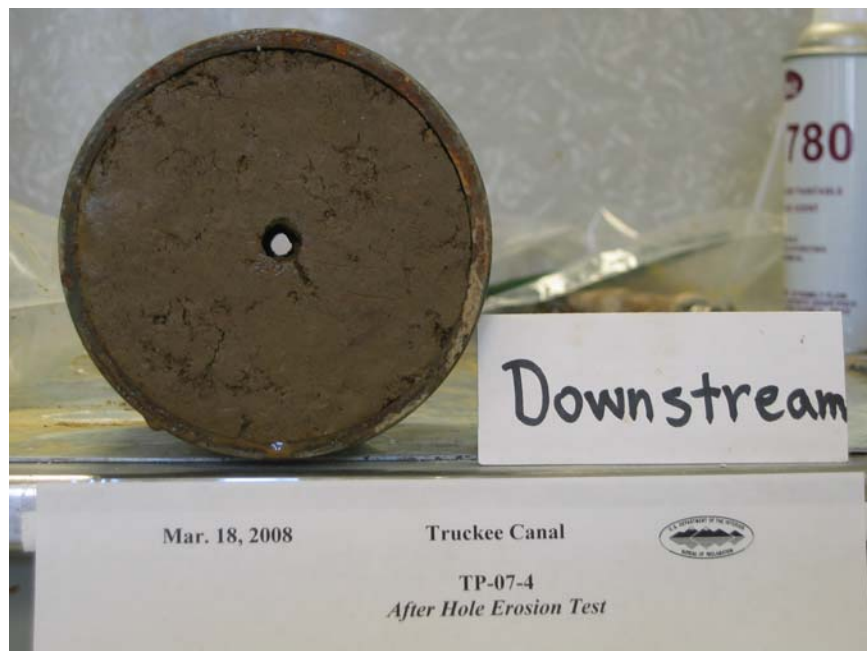
Figure 12 - TP-07-4 HET test specimen photos (a) U/S and (b) D/S after test. This test was successful.

The TP-07-4 sack sample did not contain enough material to allow for a complete laboratory compaction test. As a result, most of the HET testing was performed on the other sack sample. However, one HET specimen was prepared from TP-07-4 using similar compaction effort (3 layers, 5 blows per layer, 5.5 lb rammer, 12 inch drop, compaction energy=2475 ft-lb/ft³) as was used for the TP-07-1 specimens. However, because this specimen was compacted at the as-received moisture condition, it was probably compacted in a condition that was closer to or maybe even wetter than optimum moisture content. The compacted dry density of the specimen was 96 lb/ft³, which is consistent with this observation.

The HET of this specimen was fully successful, with a nicely controlled enlargement of the hole, progressive erosion and accelerating flow at 800 mm of head, and essentially no entrance or exit scour. The I_{HET} index value was computed by two methods and was in the range of 3.9 to 4.1 (I_{HET} group 4 - moderately slow erosion). This indicates about 2 or more orders of magnitude difference in erosion rate, compared to the TP-07-1 materials compacted to 80% of maximum density at 2% dry of optimum moisture content. This test illustrates the dramatic effect that compaction conditions can have on erodibility. Hanson and Hunt (2007) [9] have demonstrated similar effects of compacted dry density and moisture content on soil erodibility measured by the JET method.

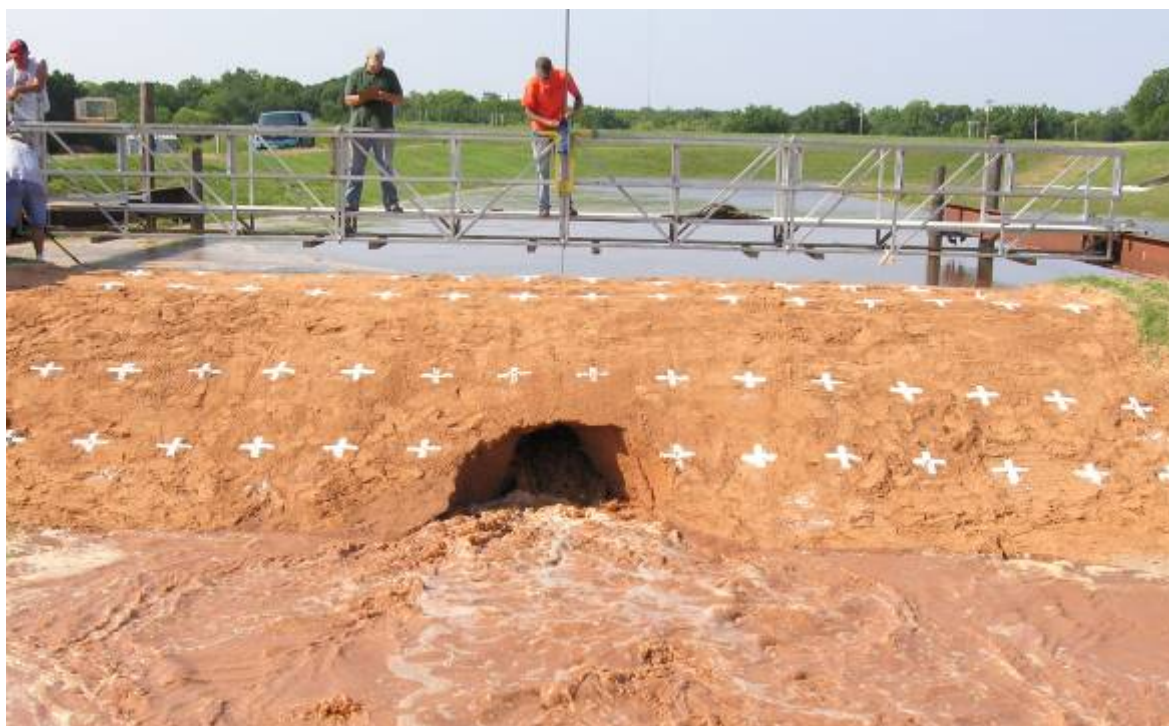
Figure D-1. — Piping test P1, 9 minutes after initiation of piping failure. Note that headcutting down to the base of the embankment is occurring simultaneously with enlargement of the piping hole, which was initiated at the elevation of the lower row of markers.

Tested embankments were of homogeneous construction, utilizing three soils obtained from borrow areas or stockpiles on the laboratory grounds. Each embankment was constructed to a height of 4 ft with a 6 ft crest width and 3:1 upstream and downstream slopes (Fig. D-1). A 1.5-inch diameter pipe was embedded in each embankment and pulled out by a tractor to initiate each test. Each embankment impounded a small reservoir supplied continuously with flow from Lake Carl Blackwell (immediately upstream from the laboratory). A long-crested weir that bypassed excess flow around the test embankments allowed the reservoir level to be held approximately constant during the course of each test.

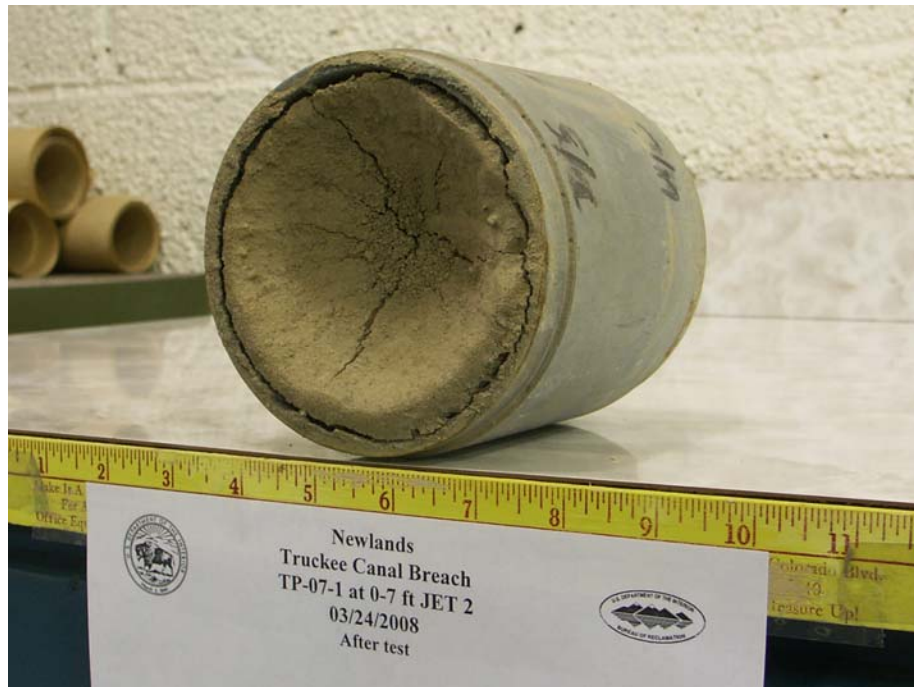
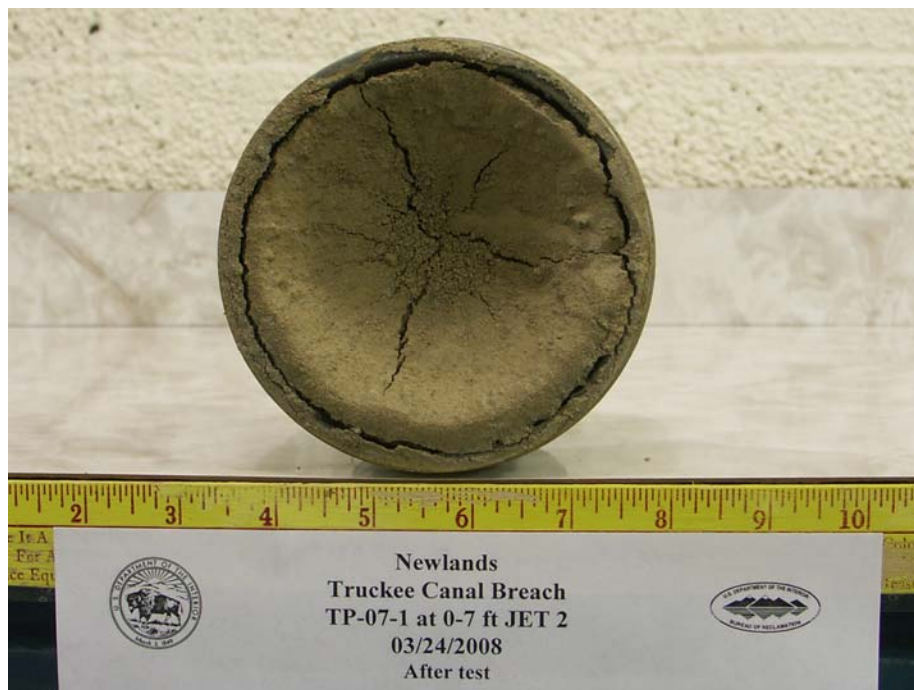
Figure D-3 (a) and (b) – Post-test photos of TP-07-1 JET 2 specimen, after oven drying. This test used a jet pressure of only 1.65 inches of water.
